# Manhole Inspection Summary

## Manhole # S15QQ1030MH

**Location** Address: **20 CATALPA CT**

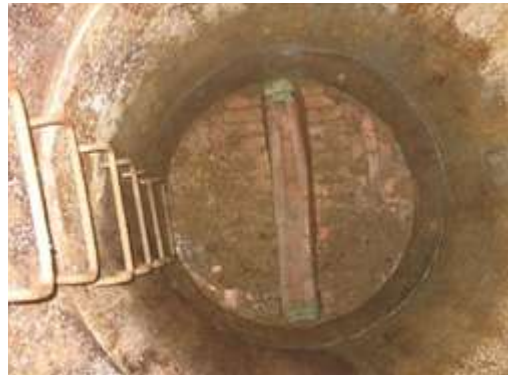
Top View

Evidence of surcharge - Bench debris.

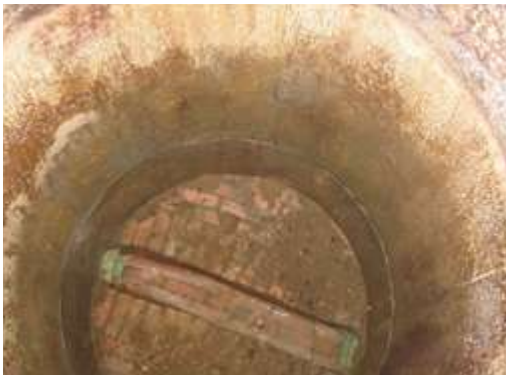
Defect

Adjustment, Corbel and Barrel infiltration - other side.

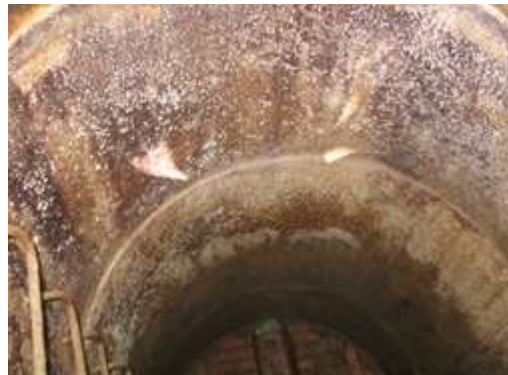
Defect

Adjustment, Corbel and Barrel infiltration.

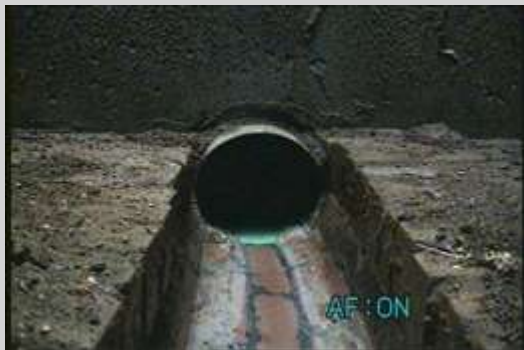
### 8 in. Circular Gravity Sewer Pipe Out @ 12 O'Clock

Invert Depth: **9.67** (ft.) Flow Characteristics: **Slow**

Infiltration: **None** Pipe Seal Cond: **Unknown**

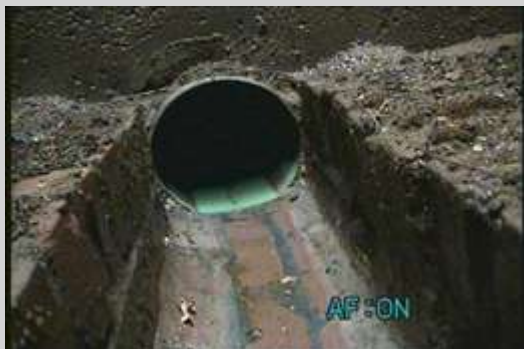
### 8 in. Circular Gravity Sewer Pipe In @ 6 O'Clock

Invert Depth: **9.64** (ft.) Flow Characteristics: **Slow**

Infiltration: **None** Pipe Seal Cond: **Unknown**
